SUFFOLK CENTRE

TIPS AND IDEAS

Toilet Leaks – (some say no better place?)

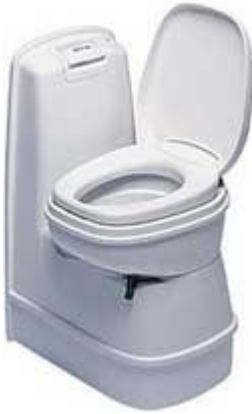
It appears that the flush water can splash and leak at the point where the flush button (electric flush) or flush handle is positioned. This is a removable cover to allow pump changes/maintenance and it does not have a 100% watertight seal guarantee.

On making enquiries to the manufacturers, Thetford, I was politely directed to their instruction leaflet for the toilet, which clearly states that before each journey the flush tank should be drained down to avoid possible leaks staining flooring etc.
