## SUFFOLK CENTRE

### TIPS AND IDEAS

**Bulk Head mounted Gas Regulator** – all caravans manufactured from September 2003 incorporate the new 30mbar gas regulator fitted to the gas locker bulkhead. As you may have already read, problems regarding gumming up/blocking of the regulator have been experienced by a number of owners, and this has been attributed to an oily fluid from within the rubber gas hose connecting the gas cylinder to the regulator.

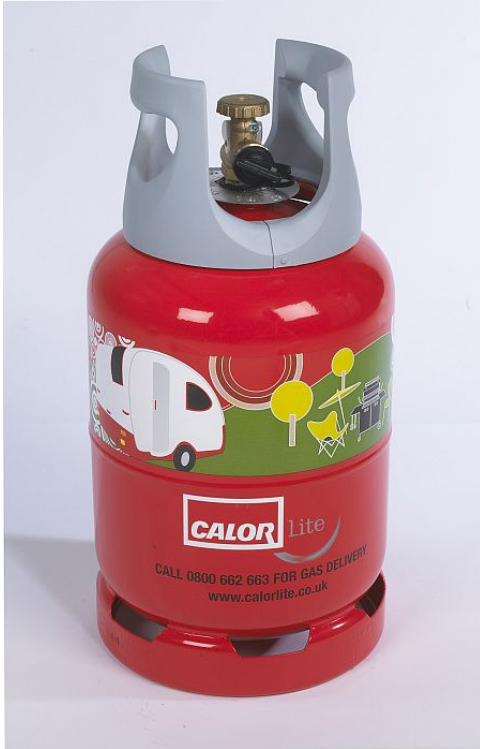
The “Practical” article published in the July 2007 Caravan Club magazine featured on the problem and steps that could be taken to avoid it happening. In the article it stated that the regulator position should always be above the level of the valve on the gas bottle and to ensure that the connecting hose has a fall back to the cylinder and not a drop into the regulator. The vertical position of the regulator makes this difficult to totally achieve and as the article suggested the solution is to fit a 90° elbow to the top of the regulator to gain height for the hose connection and so allow it to fall back to the cylinder.

Elbows suitable for fitting to the Truma regulator should be available via your dealer but if you have difficulty sourcing one (as I did) then they are available from [www.leisureshopdirect.com](http://www.leisureshopdirect.com) (telephone 0845 4300325) for £8 approx including postage.

I understand Avondale Caravans use a different regulator that hasn't shown problems and all 2008 model year vans produced during the later half of 2007 should incorporate the elbow as standard.
